# Experimental Study on Lateral Resistance of Timber Post and Beam Structures

**Reporter :**

**LIU Yingyang**

**2013.08.20**

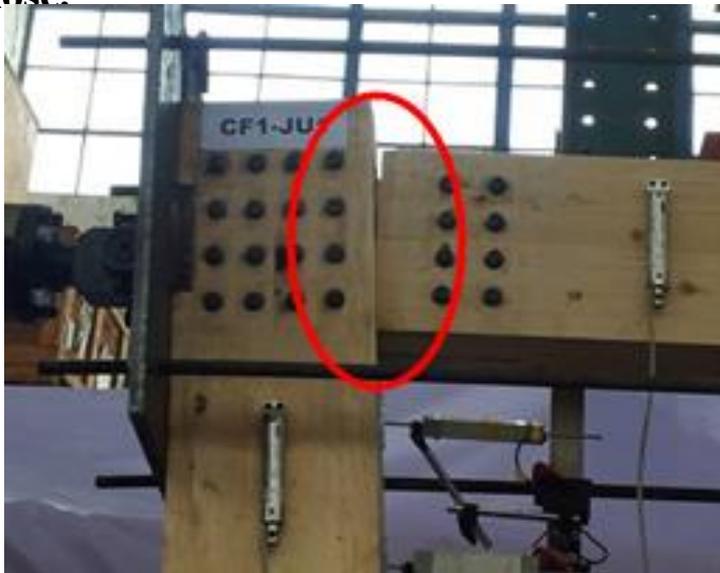
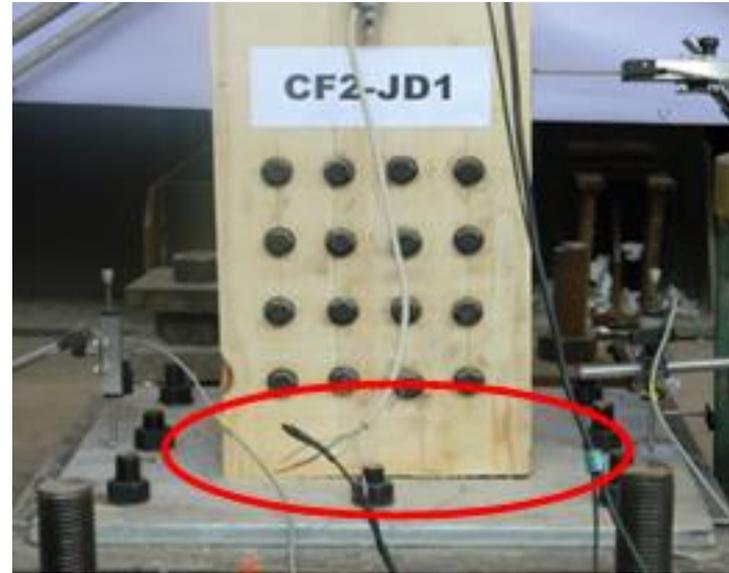
When lateral displacement turned to 10 % of the ultimate displacement (26mm), the joints showed up local pressing close.

The force transmitting of the beam-column joints: ①Indirect force transmitting: column→bolts→steel plate→bolts→beam; ②Direct force transmitting by the local pressing close.

The force transmitting of the column-bottom joints: ①Indirect force transmitting: column→bolts→steel plate→foundation; ②Direct force transmitting by the local pressing close.

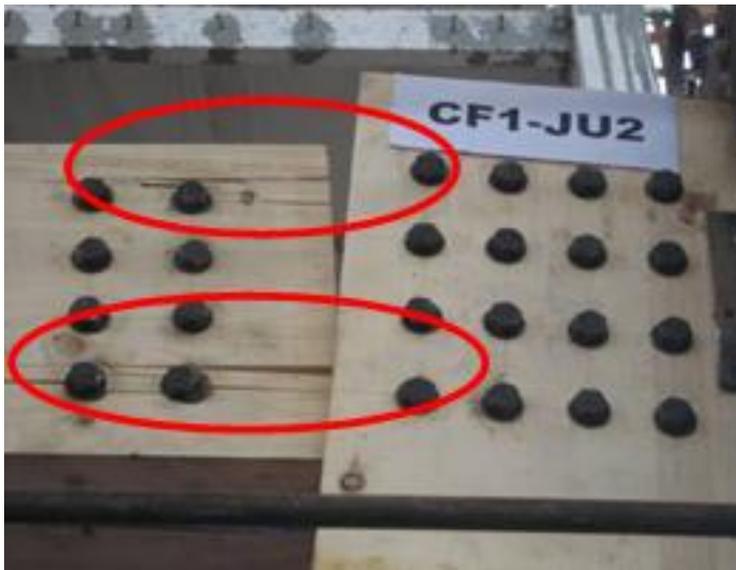
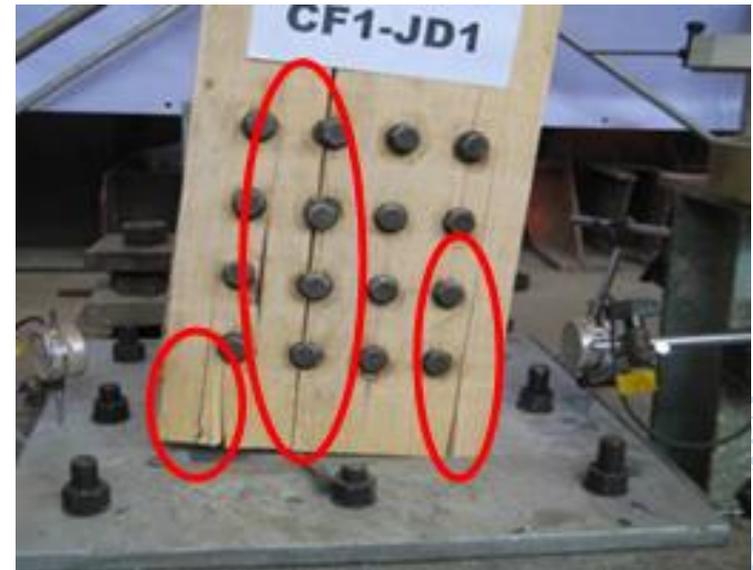
When lateral displacement turned to 10%~20% of the ultimate displacement (26mm~52mm), the column-bottom joints splitted because of the local pressing close. The cleavage cracks of the ends of the beam happened when the lateral displacement turn to 40%~60% of the ultimate displacement (104mm~156mm). The cleavage cracks of both the column-bottom joints and the ends of the beam continued to develop in the subsequent loading process.

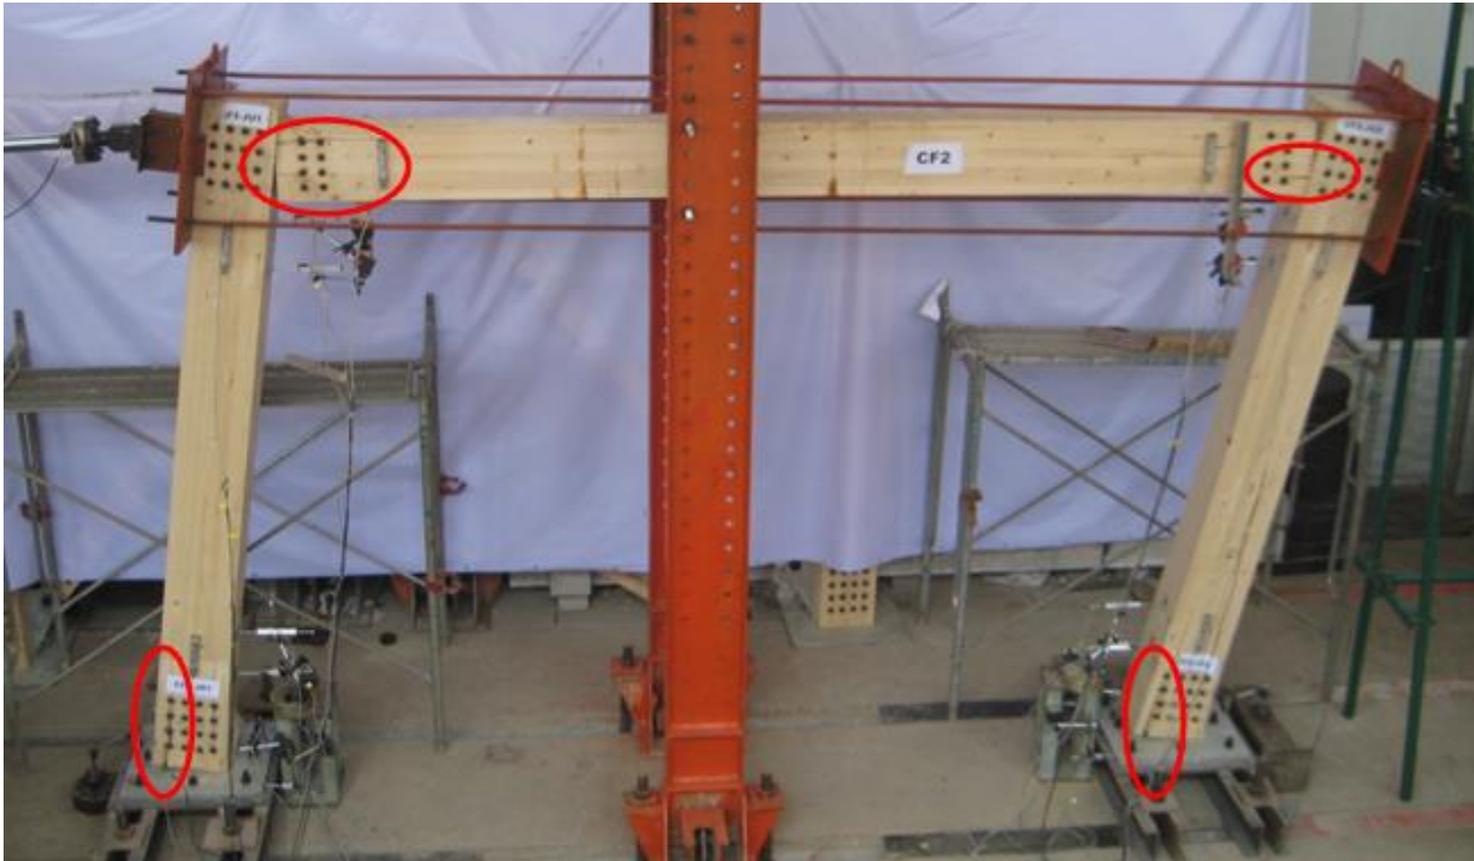
The destruction was only found in the joints, while the mid-span section of both the beam and column was intact, showing up the “weak-joint and strong-member”.

**(1) The local pressing close, which leads to deformation perpendicular to the grain and splitting, should be considered in the design. The failure mode of the timber post and beam structures shows up the "weak-joint and strong-member".**

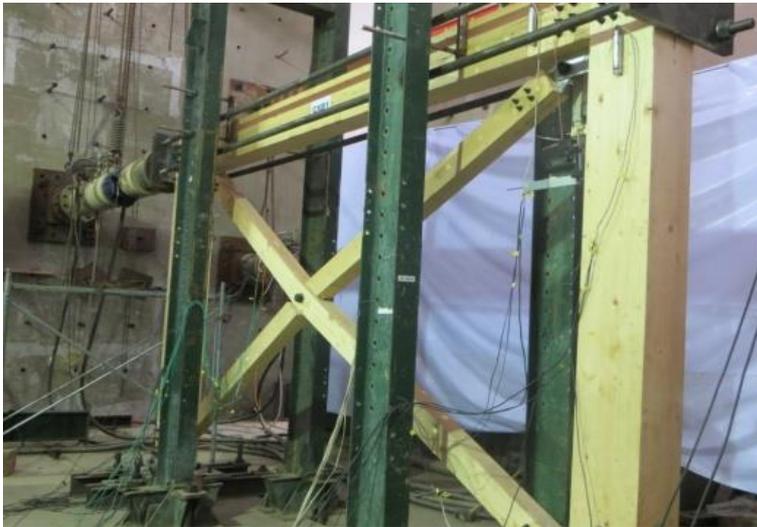
When the lateral displacement turned to 40%~60% of the ultimate displacement (16mm~24mm), the out-of-plane deformation of the brace appeared.

out-of-plane deformation (thrust)

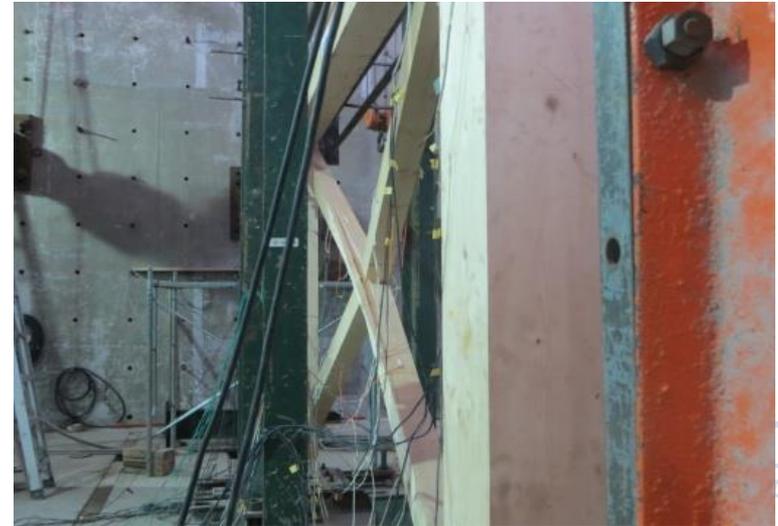
out-of-plane deformation (pulling)

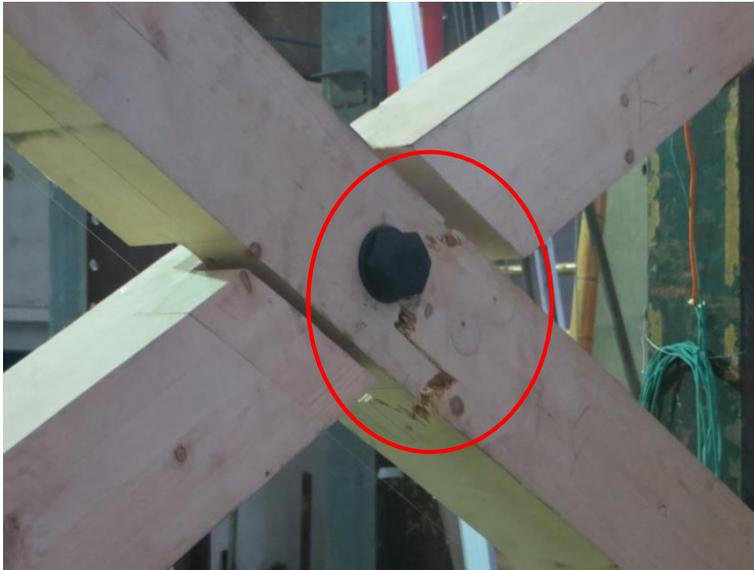
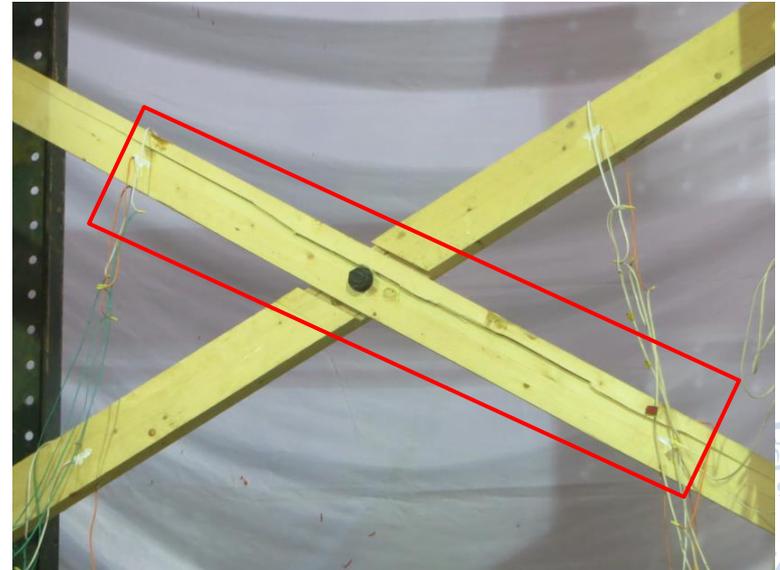
When applying thrust load on the specimen of CXB1 at 31.6mm, in the second reversed cycles of the amplitude of the 80% of the ultimate displacement (32mm), the tensile element of brace splitted significantly but the compressive element of brace was intact. When applying pulling load at -31.1mm in the same cycle, the previous compressive one splitted under the tensile stress. The significant load drop in the third cycle meant the destruction of the structure.

Cleavage of the tensile element of brace

**(2) The failure mode of the X-brace structures is that, the tensile element of brace splits. The reason is that, the axial tension stress at the hole, transferred to the tension perpendicular to the grain, leading to splitting. It is necessary to avoid the holes on tension members.**

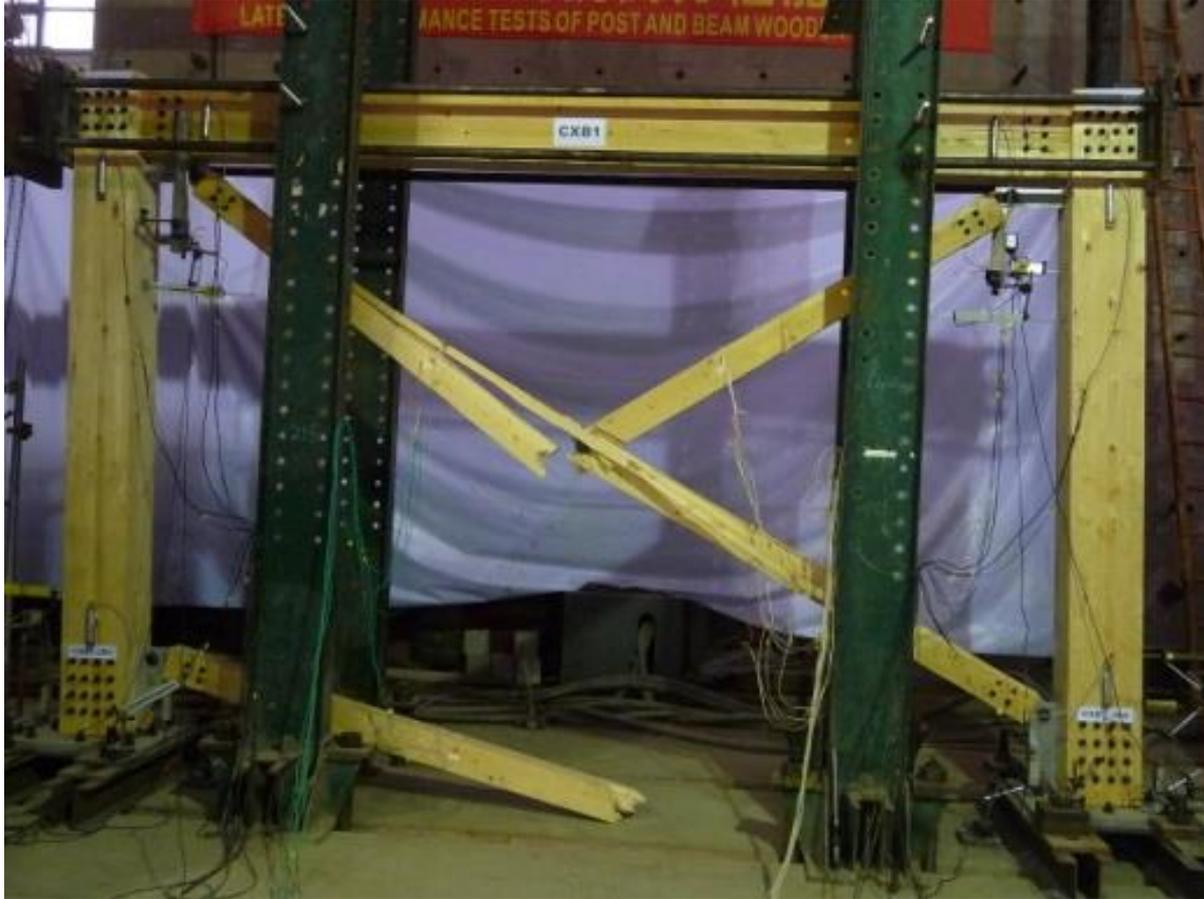
General failure mode of CXB1

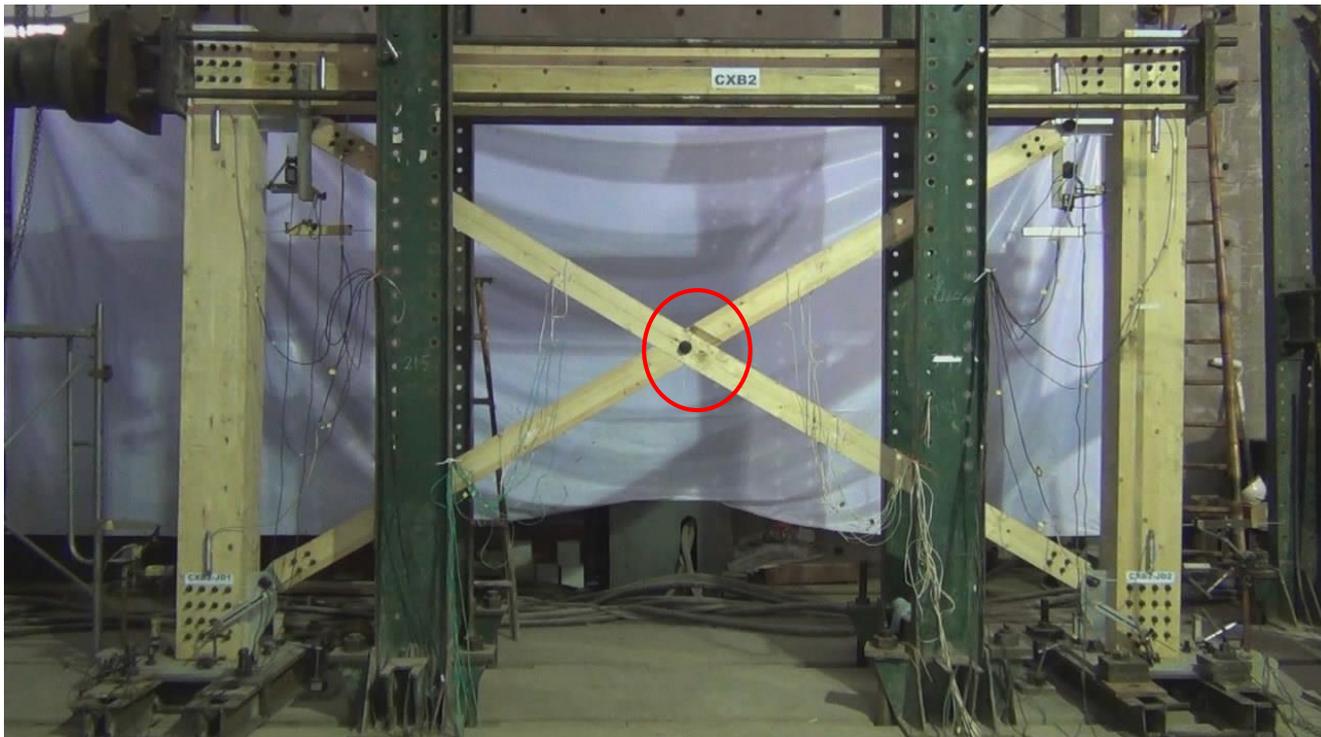
The failure mode of the specimen of CXB2 was similar to CXB1.

General failure mode of CXB2

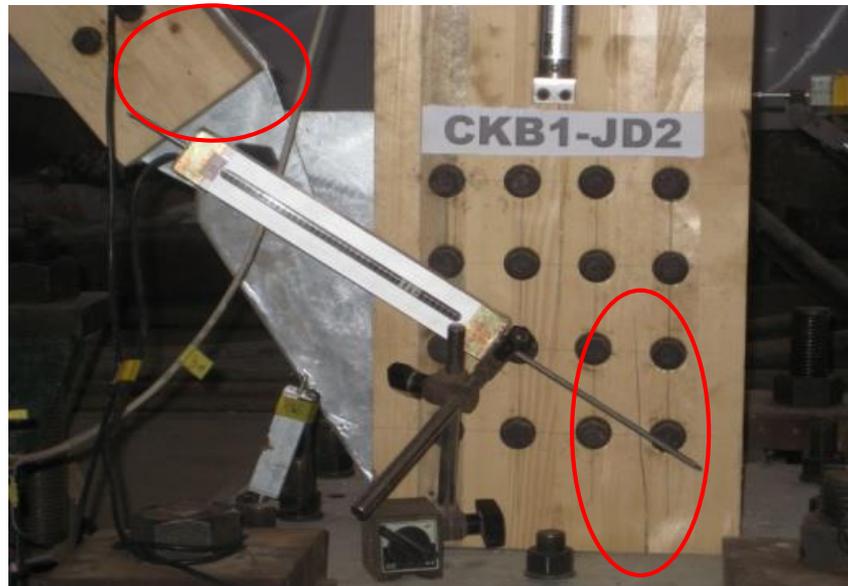
The steel plate of the brace joints rotated slightly when the lateral displacement turned to 16mm~24mm. The column-bottom joints splitted, When lateral displacement turned to 24mm~32mm. The cleavage cracks of the ends of the beam happened when the lateral displacement turn to 32mm~40mm.

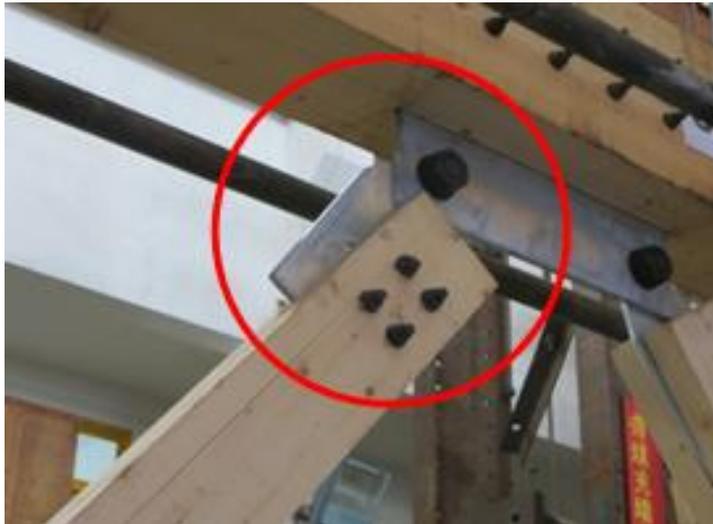
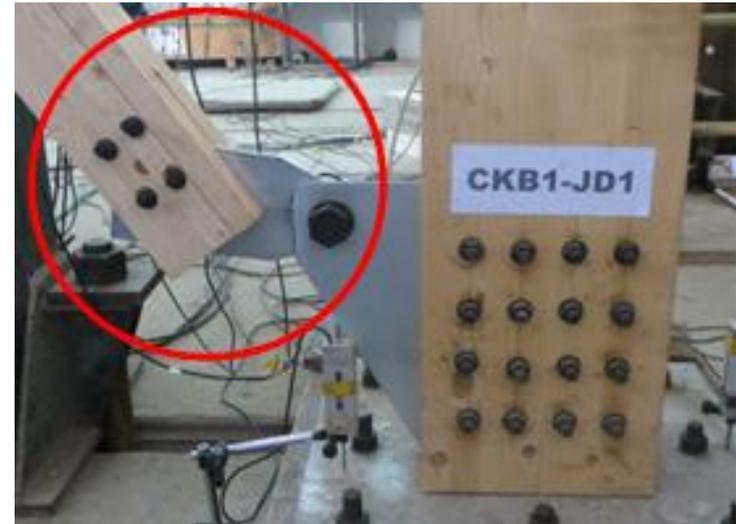
When lateral displacement of the specimen of CKB1 turned to 140%~160% of the ultimate displacement (56mm~64mm), the bolts of the brace joints were cut, meaning the destruction of the structure.

The failure mode of the specimen of CKB2 was similar to CKB1.

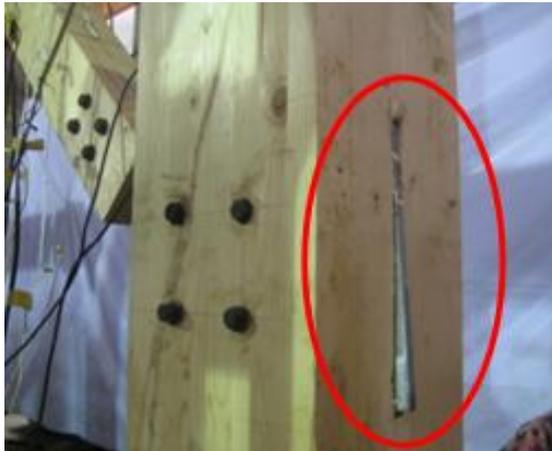
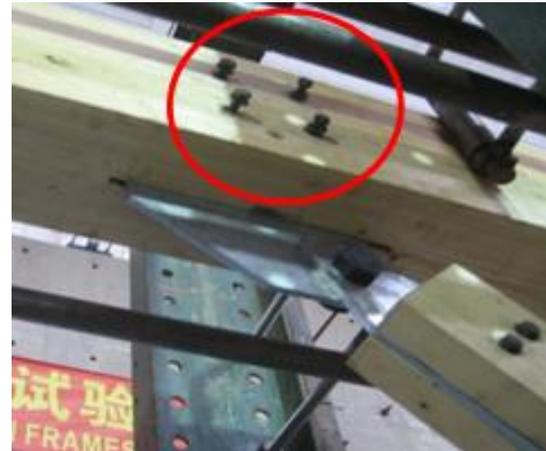
When lateral displacement turned to 24mm~32mm, the column-bottom joints splitted. When lateral displacement turned to 64mm~80mm, the steel plate of the brace joints rotated slightly.

When lateral displacement turned to 80mm~152mm, the bolts of the brace joints were cut. In this loading process, the bearing load reached the peak.

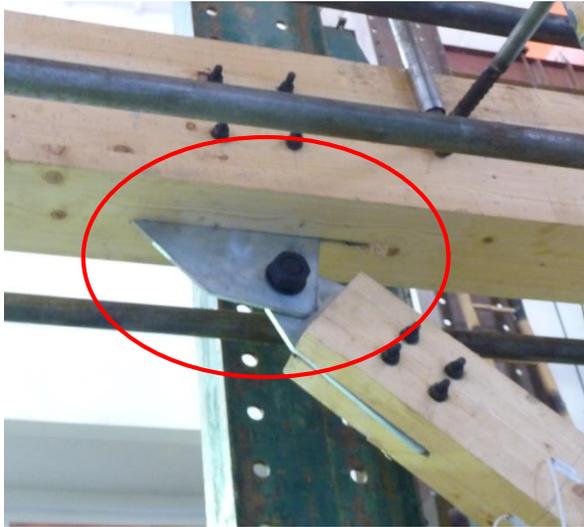
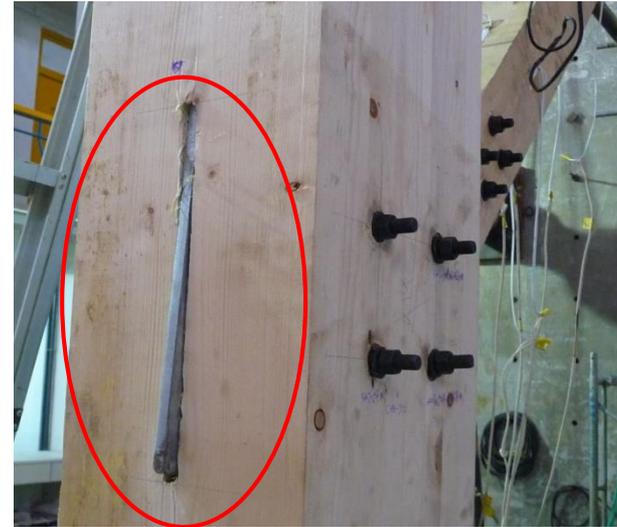
In the subsequent loading process, although the bolts were cut, the braces stuck in the wooden frame continued to transmit the compressive force, resulting the slowly decline of the bearing load.

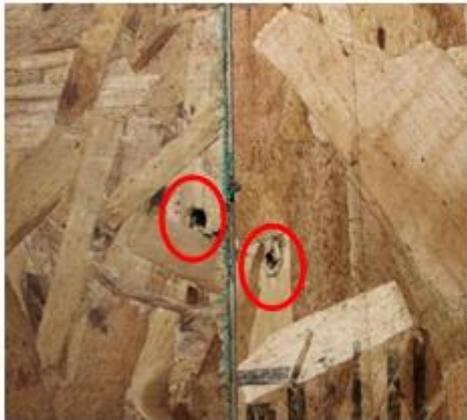
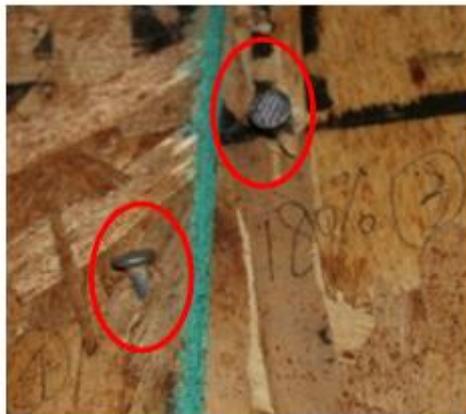
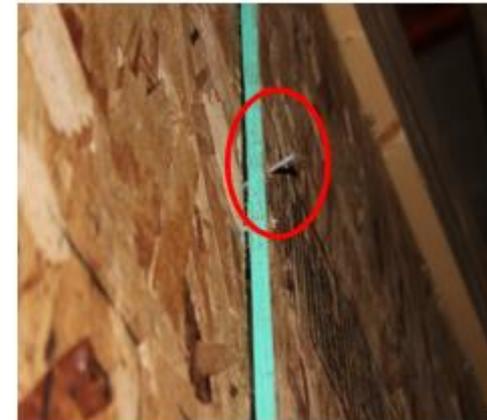
When lateral displacement turned to 40mm~56mm, the nail were striped gradually form the panels and the column-bottom joints splitted. When lateral displacement turned to 64mm~80mm, the striping of the nails from the panels and the cleavage cracks of the column-bottom joints continued to develop. When the lateral displacement turned to 80~232mm, the panels striped from the studs, leading to the stagger displacement between the panels.

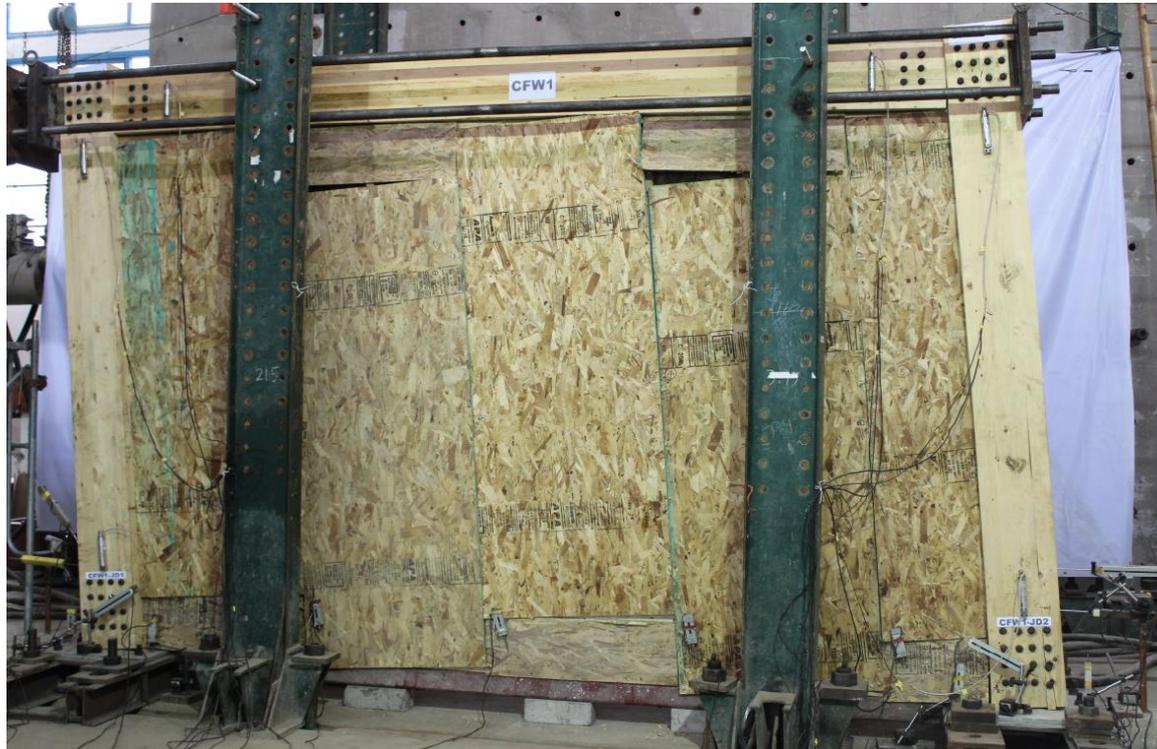
Although the nails became invalid gradually, but the hooping effort of the wooden frame maintained the load bearing capacity, showing up a good ductility.
